Final Report

Air Canada Boeing 767 C-GAUN

Accident — Gimli, Manitoba

July 23, 1983

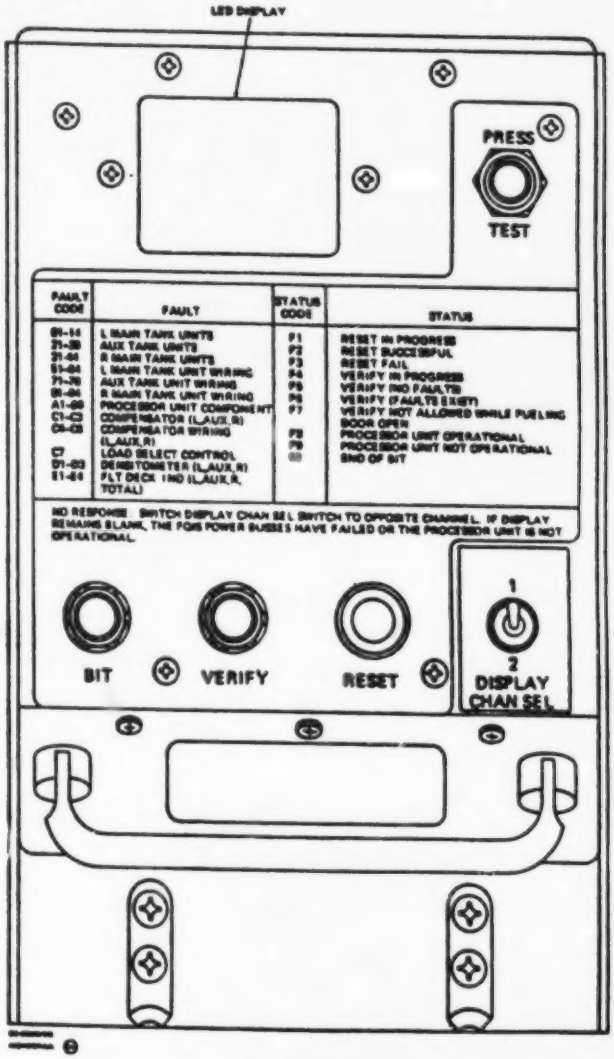
HG1057AA Digital Fuel Gauge Processor, Front Panel
Figure 3

BITE stands for Built-in Test Equipment. It refers to the fact that the processor had been designed and built so as to be able to identify faults within its own system. Before doing the test, he reset the number 2 channel circuit breaker. This caused the fuel gauges in the cockpit to go blank.

Mr. Ouellet was not satisfied with the test and decided that the processor had to be replaced. When he tried to order a new one, he was told that none were available in Montreal, but that one had been ordered to be available that night in Edmonton.
